# CHISANA

## HISTORIC STRUCTURE REPORT

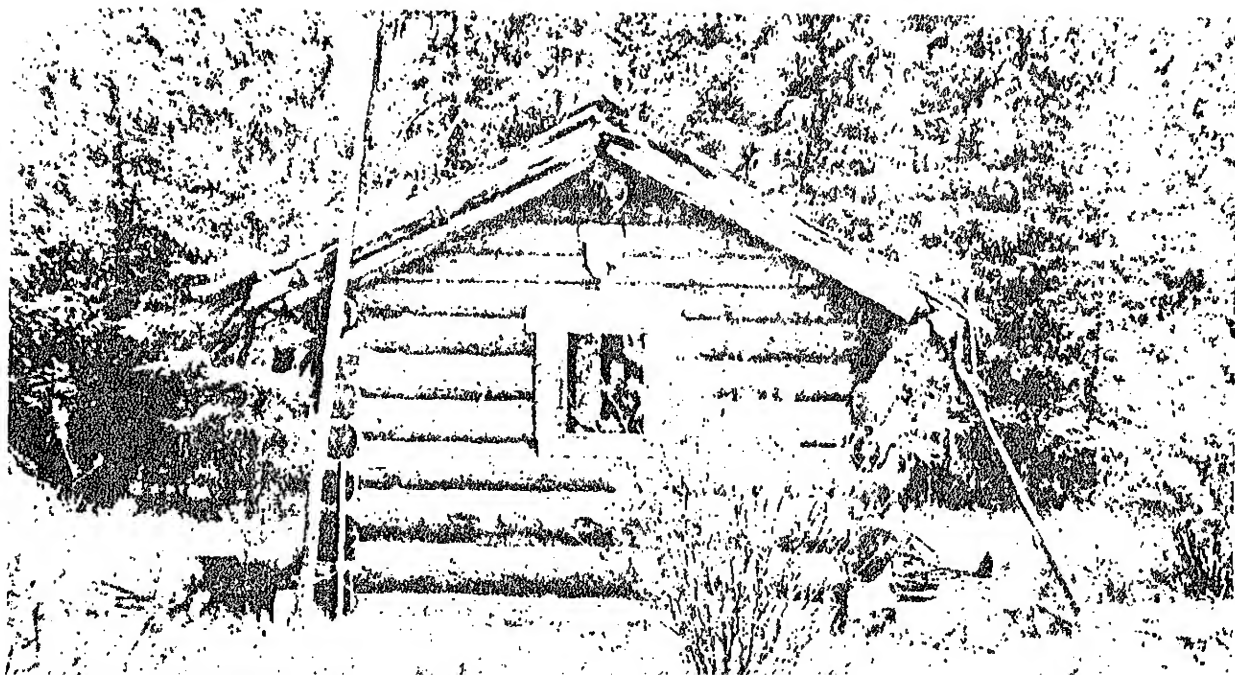
Photograph 4  
Women's Jail, Chisana  
West Elevation.

e window on the west end appears to have been a later addition. It is a different style from the north and south windows and is essentially large enough to crawl out of (not very efficient in a fire). The frame is loose, all boards are weathered and the stops are missing as is the glazing. The shelf above the window is in good shape.

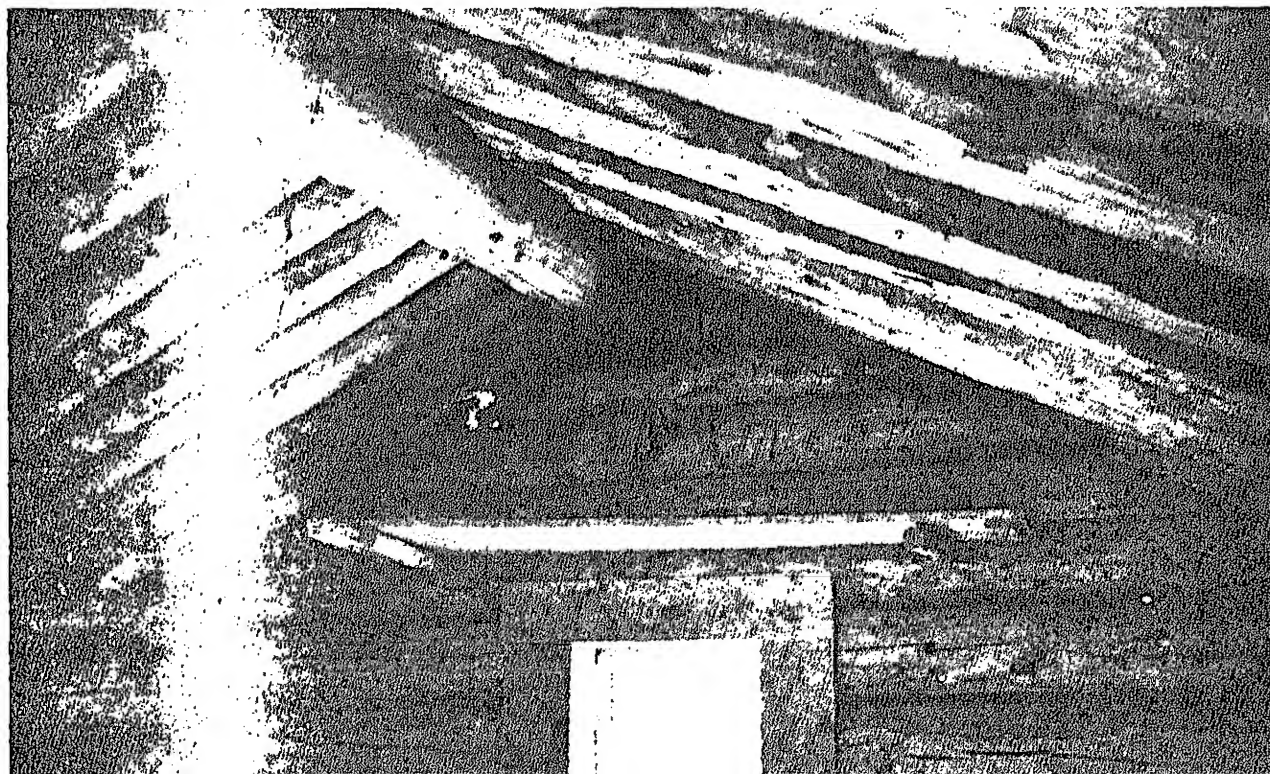
Photograph 8  
Women's Jail, Chisana  
Interior; West wall, shelf & window.

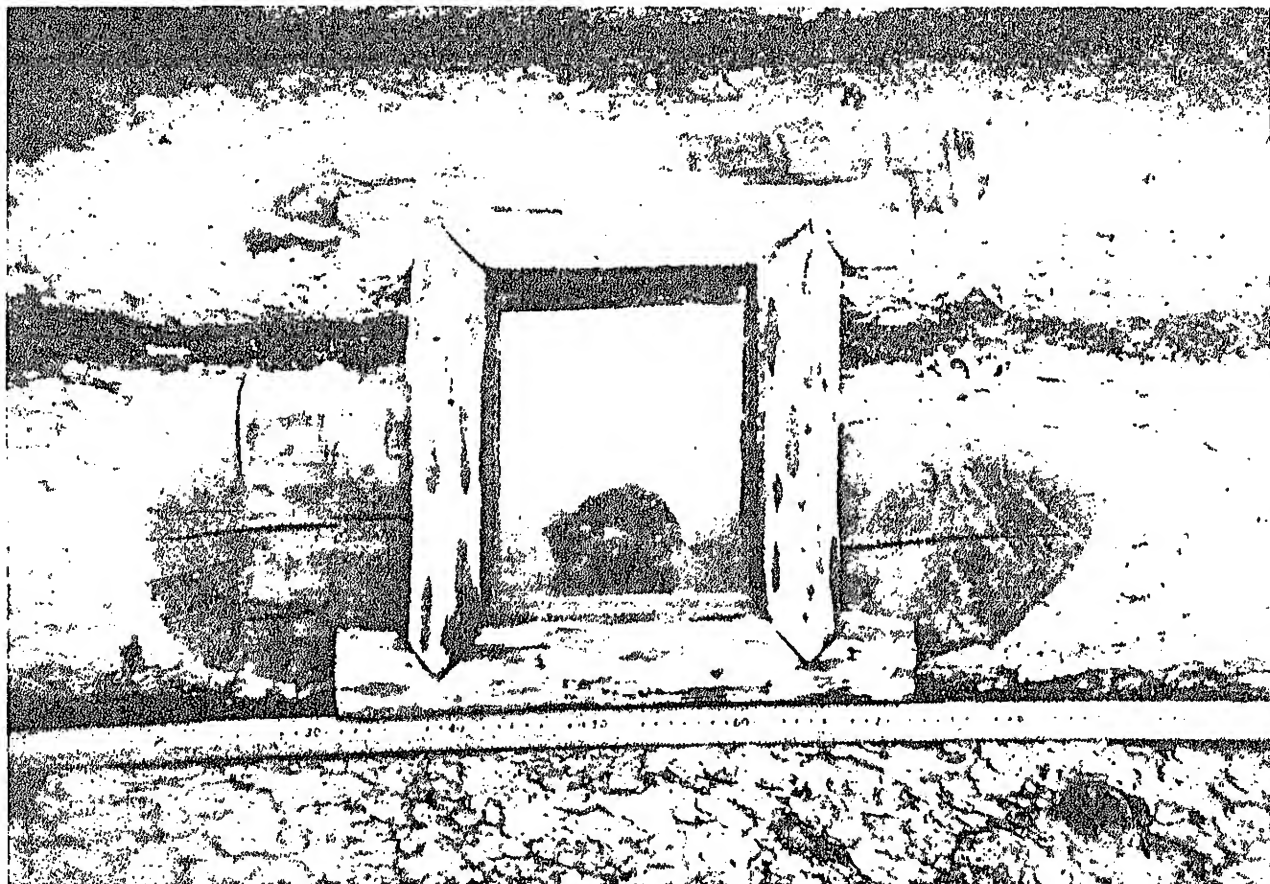
Photograph 9  
Women's Jail, Chisana  
Exterior; Window on north wall.

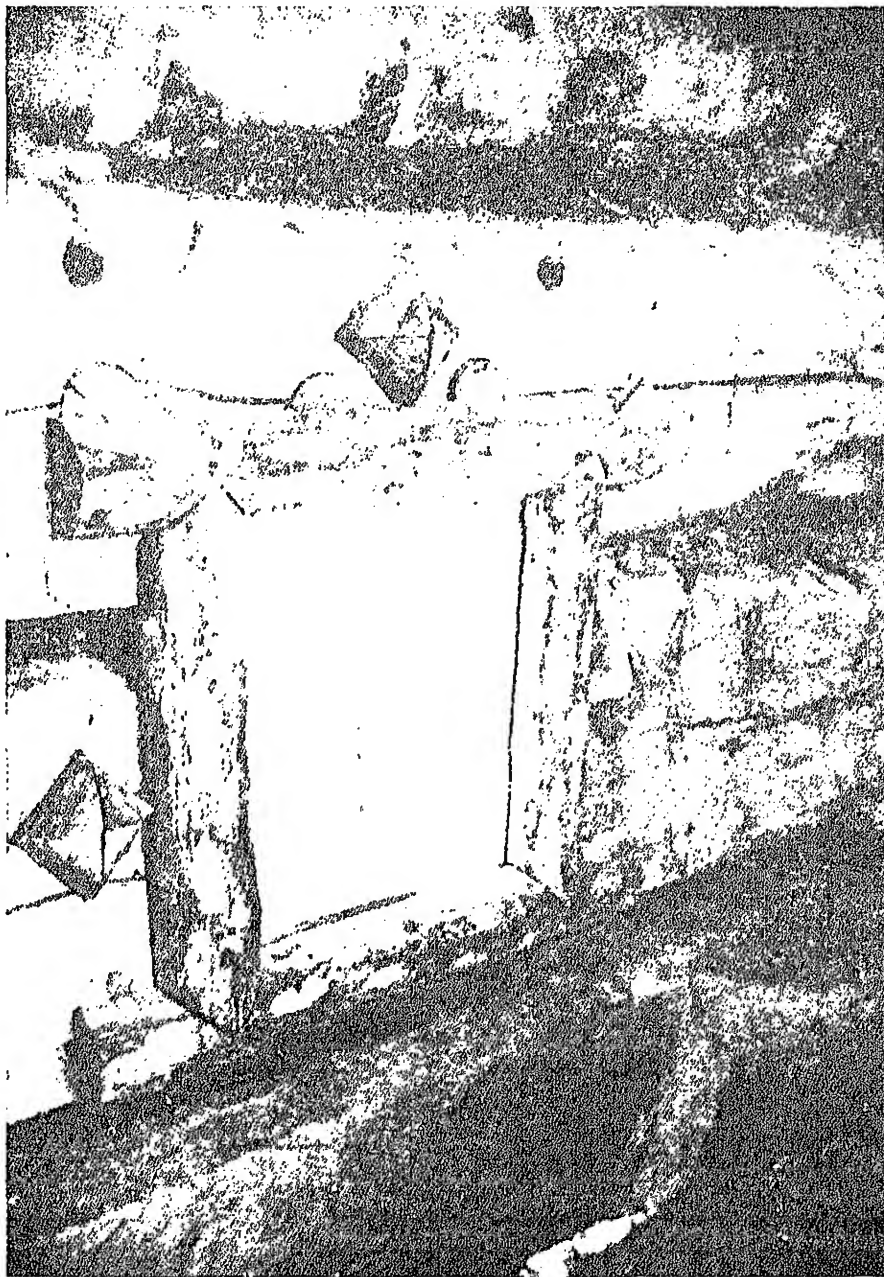
Photograph 10  
Women's Jail, Chisana  
Interior; Window on north wall.

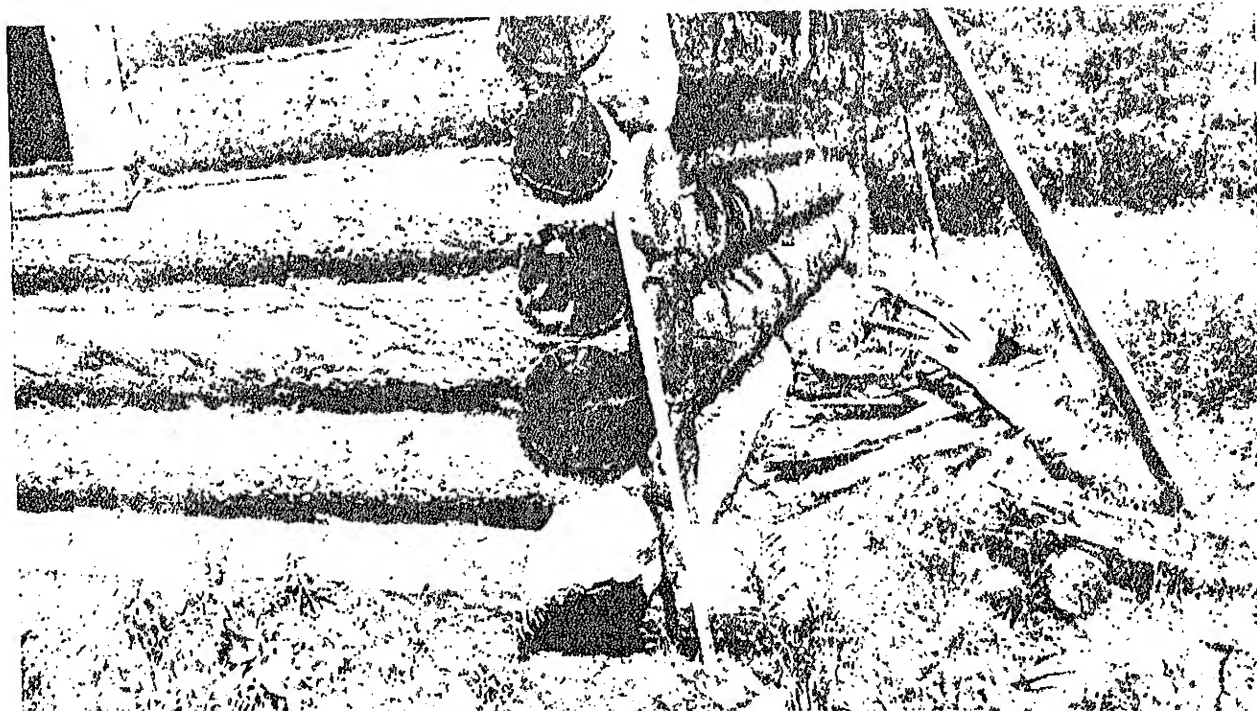
Photograph 12  
Women's Jail, Chisana  
Northwest corner, log connections.

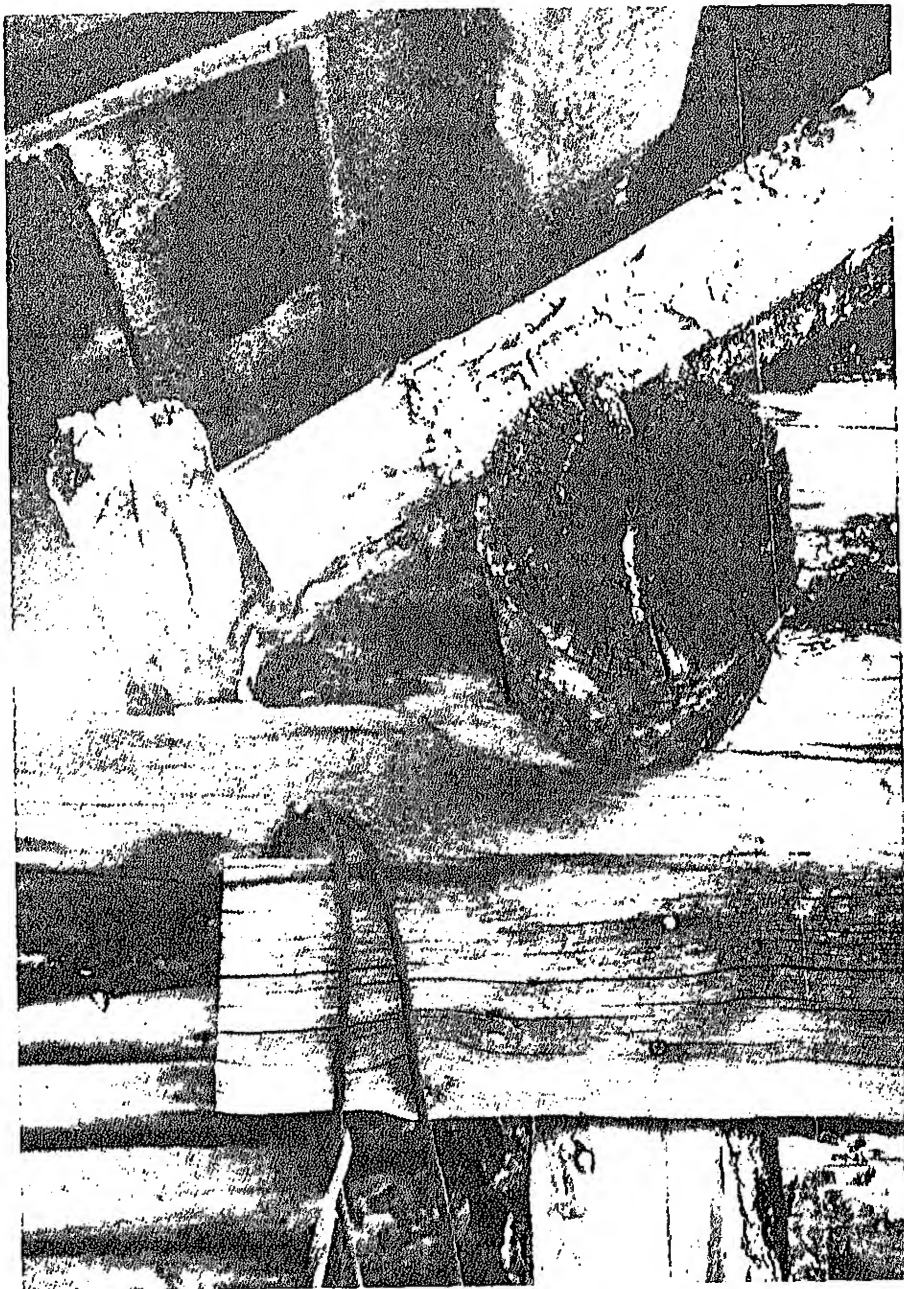
Photograph 19  
U.S. Commissioner's Court, Chisana  
Junction of the ceiling timbers,  
butting pole, eave log and  
plate log w/newer roof above  
ceiling members

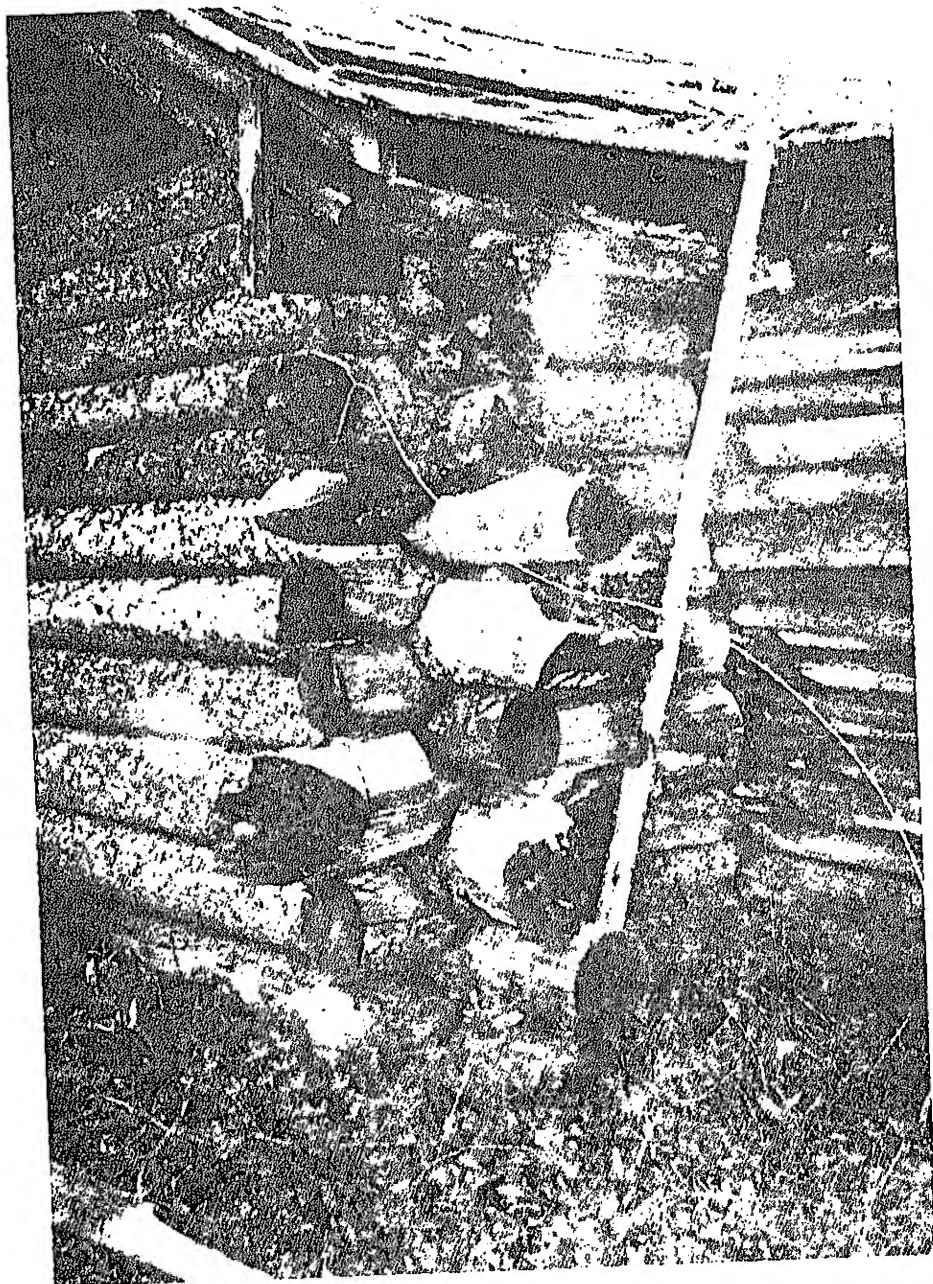
Photograph 20  
U.S. Commissioner's Court, Chisana  
V-notched log corner; showing  
junction of addition logs and  
newer roof.

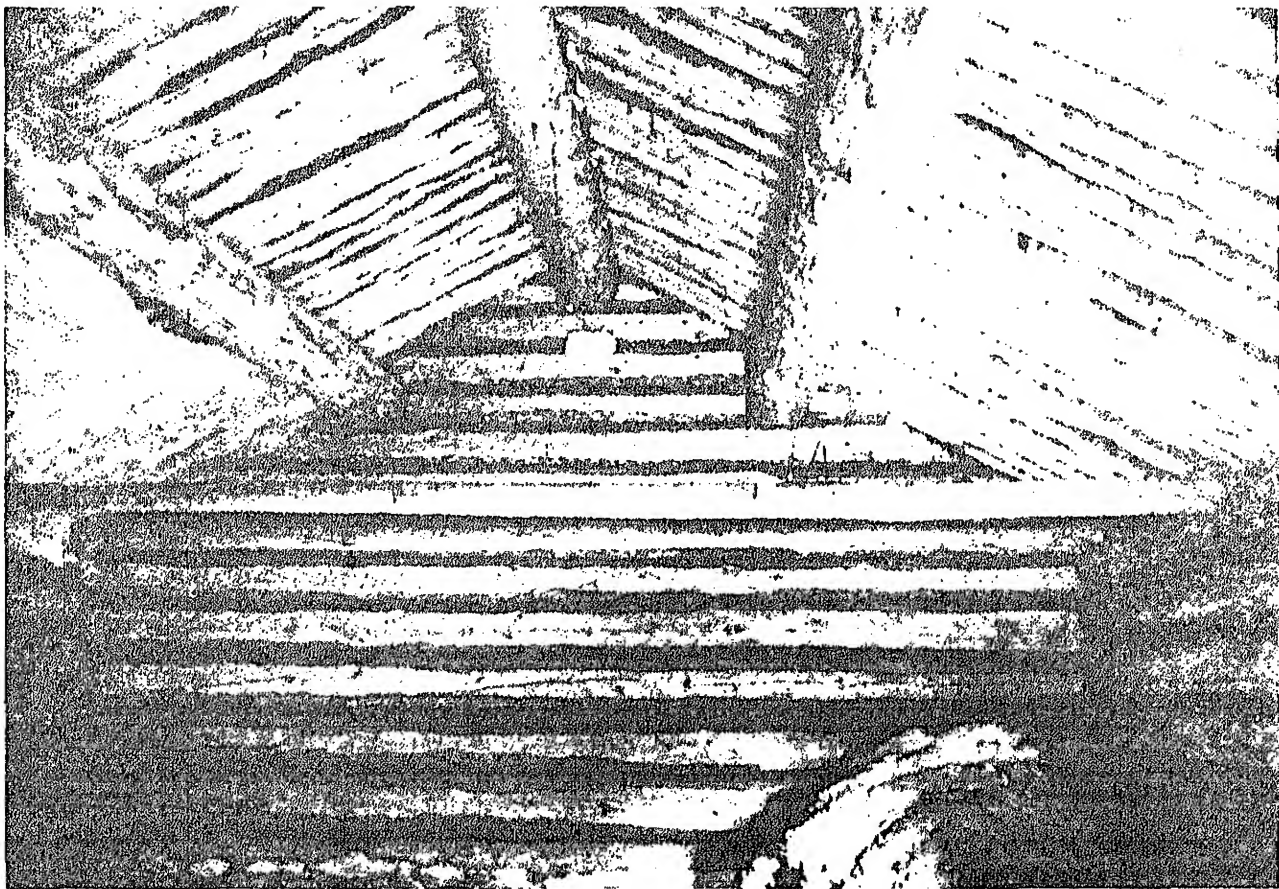
Photograph 21  
U.S. Commissioner's Court, Chisana  
Ceiling & North wall, showing split-  
log ceiling members and peeled  
purlines & ridge beam.

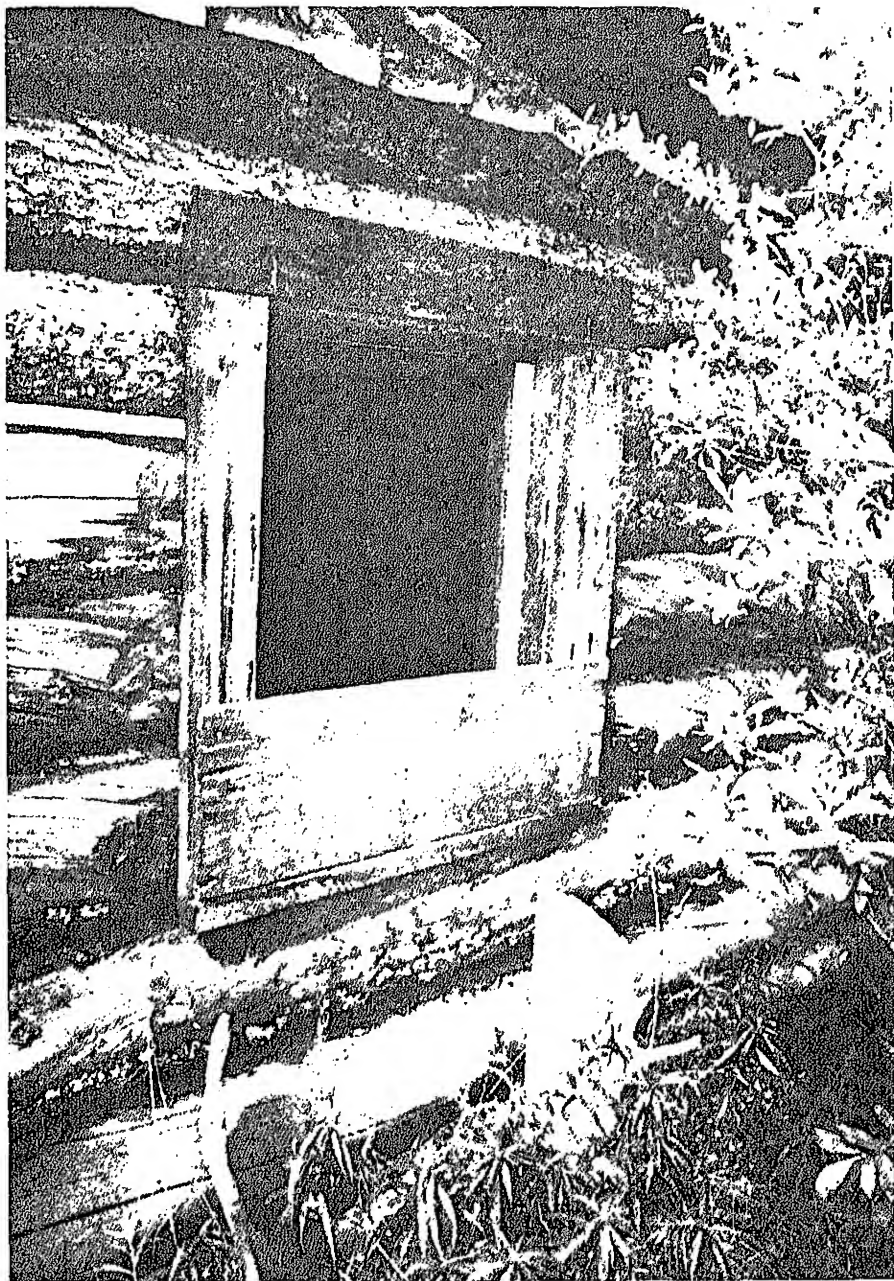
Photograph 22

U.S. Commissioner's Court, Chisana  
Window in East wall - logs hewn to  
receive flat trim pieces.

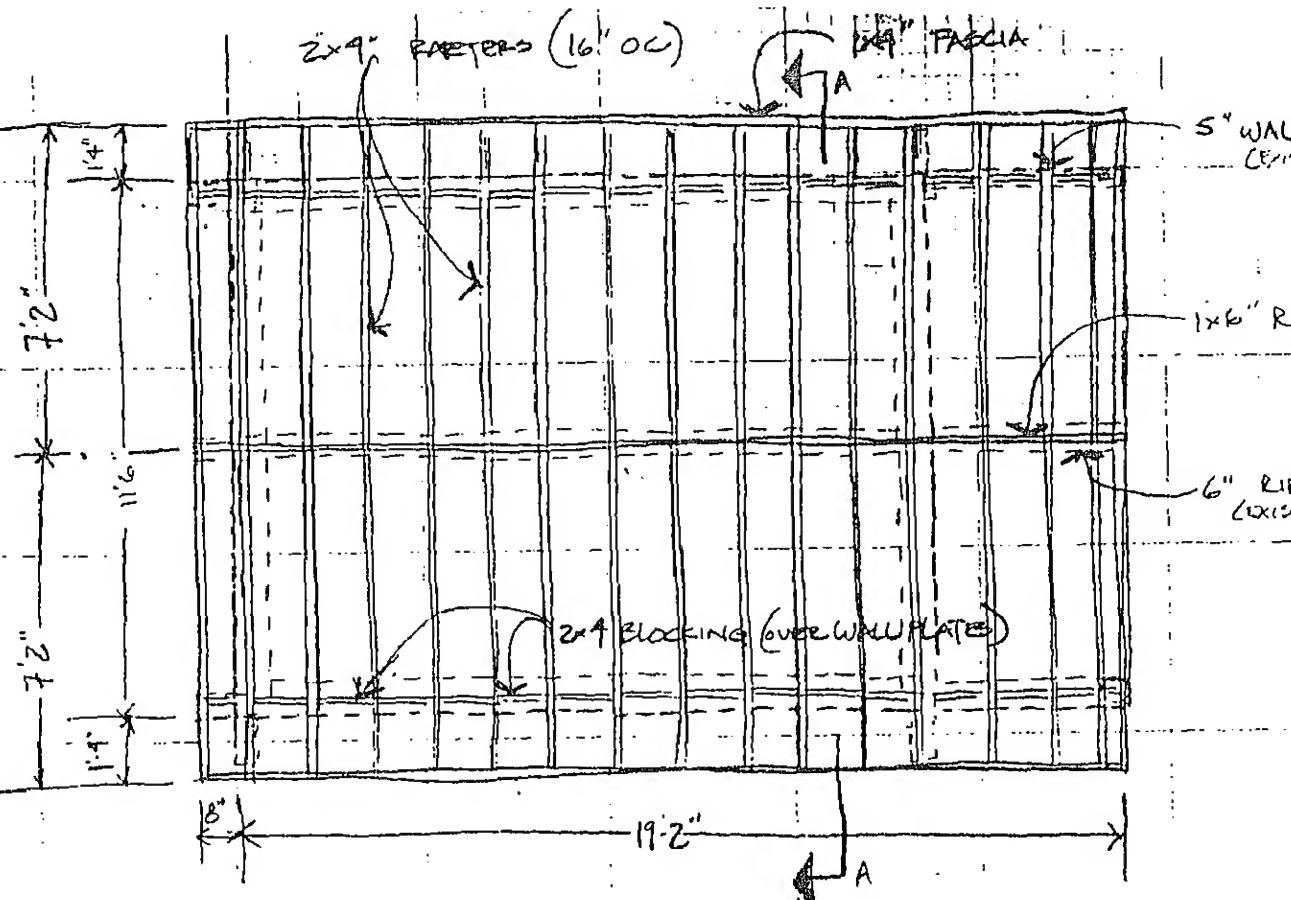
ROOF PLAN

GAD - CONSIDERABLE ROT & DECAY

ROOFING SLATS DETRIMENTAL & MISSING IN PLACES  
LARGE HOLE (4' x 6') ON SOUTH SIDE - CAUSED BY COLLAPSE OF A CEILING MEMBER.

RIDGE BEAM & WALL PLATES IN GOOD CONDITION

PLACE 1" x 4" FASCIA BOARDS ALONG CUT ENDS OF RAFTERS. (NAIL W/ 3-16D NAILS @ EACH RAFTER.)

80 LB ROOFING FELT UNDER TIN ROOFING.

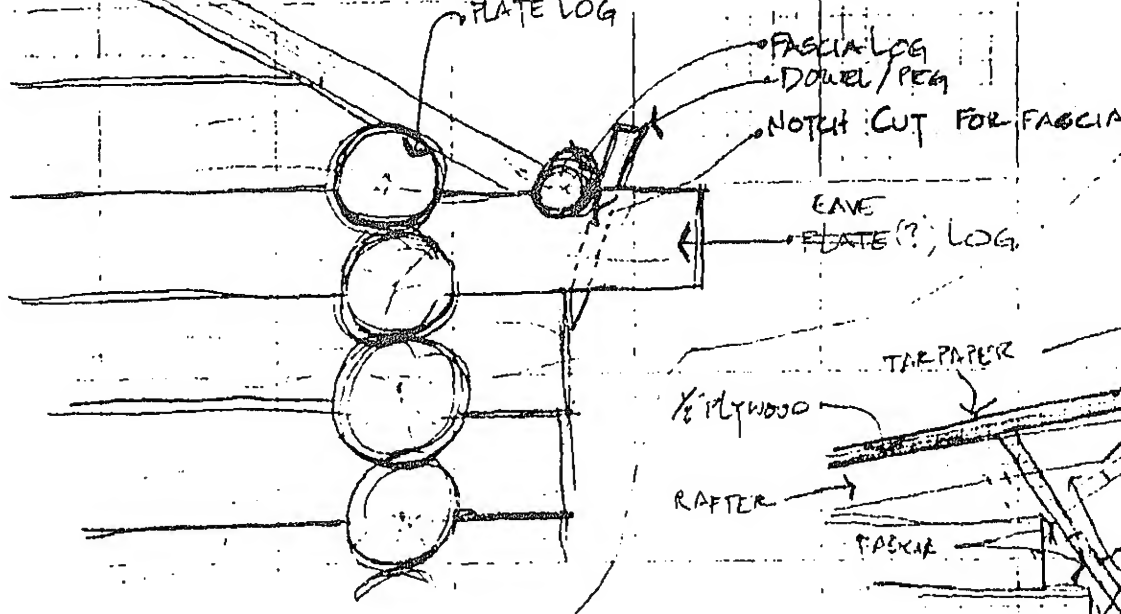
# #1 DETAIL - GABLE END FASCIA

POOR - SOD ROOF SETTING TOPS OF CEILING MEMBERS. (9' x 4' to 6" HALF SPLIT  
WHITE SPANCE LOGS (AND SHIT SIDE. DOWN 4' 6" ON WEST SIDE.)  
NEWER ROOF ON TOP W. FELT PAPER - FAIRLY GOOD SHAPE - NO SHEATHS GROWING  
LIGHTLY ASYMMETRICAL W. RIDGE SHIFTED TO EAST. (In front - Symmetrical  
STRUCTURAL MEMBERS - RIDGE, FURLING & PLATE LOGS IN GOOD SHAPE  
"PLATE" LOGS AT GABLE ENDS MISSING SUPPORT NOTCHES FOR FASCIA B  
RAFTERS (SEE DETAIL BELOW LEFT #12)  
ROOF IN ADDITION - CHANGE IN SLOPE (TO 3:12 MAX FROM 5:12)  
PLYWOOD DELAMINATING, SAGGING & WATER STAINED  
RAFTERS EXPOSED TO MOISTURE - SIGNS OF DECAY - LEFT ON NEW ROOF  
ON TOP OF PITCH. SEE DETAIL #2 BELOW LEFT

REMOVE ALL ROOFING MEMBERS OF NEWER ROOF AND ADDITION ROOF  
REMOVE SOD & CEILING MEMBERS OF MAIN CABIN  
← SET NEW PLATE LOG SUPPORTS ON GABLE ENDS W/ NOTCHES FOR FASCIA  
REPLACE CEILING MEMBERS W/ 4-6" SPLIT LOGS (W. SPOUX) SET 3/4" IN  
DOWN - 4' ON EAST SIDE - 4' 6" ON WEST  
SET NEW 9" RAFTERS ~~ON~~ ON ADDITION - 16" OC  
NAIL 1" x RANDOM WITH HEADS ACROSS ADDITION RAFTERS (15 PER DETAIL  
#12) 18" METAL FLASHING AT JUNCTIONS  
TAP PAPER OVER BOTH ROOFS  
METAL SHEET ROOFING (SMALL SHEETS "DESIGNED TO DULL OR PARTIALLY RUST")  
→ PLACE 4-5" FASCIA LOG ALONG ENDS OF CEILING MEMBERS - SETTING IN  
"PLATE" LOGS - VORTEL/PLG INTO POSITION.
